Thurrock Flexible Generation Plant

**Preliminary Environmental Information Report
Appendix 16.1: Phase 1 Preliminary Risk Assessment**

Environmental Impact Assessment
Preliminary Environmental Information Report

Volume 6
Appendix 16.1

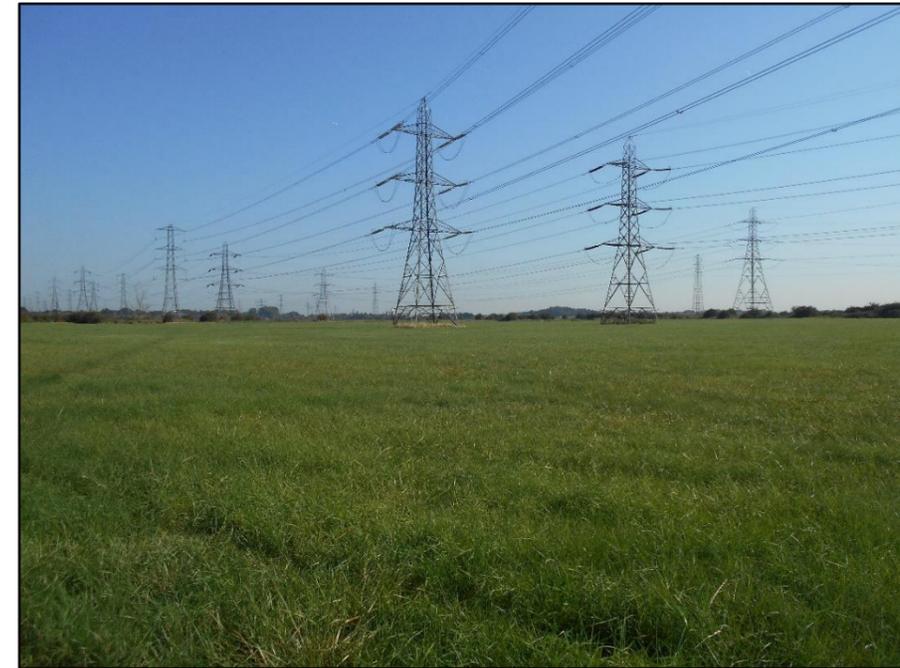
Figure 2.1: Main Development Site

2.1.5 A photograph of the main development site in its current condition, is shown in Figure 2.1.

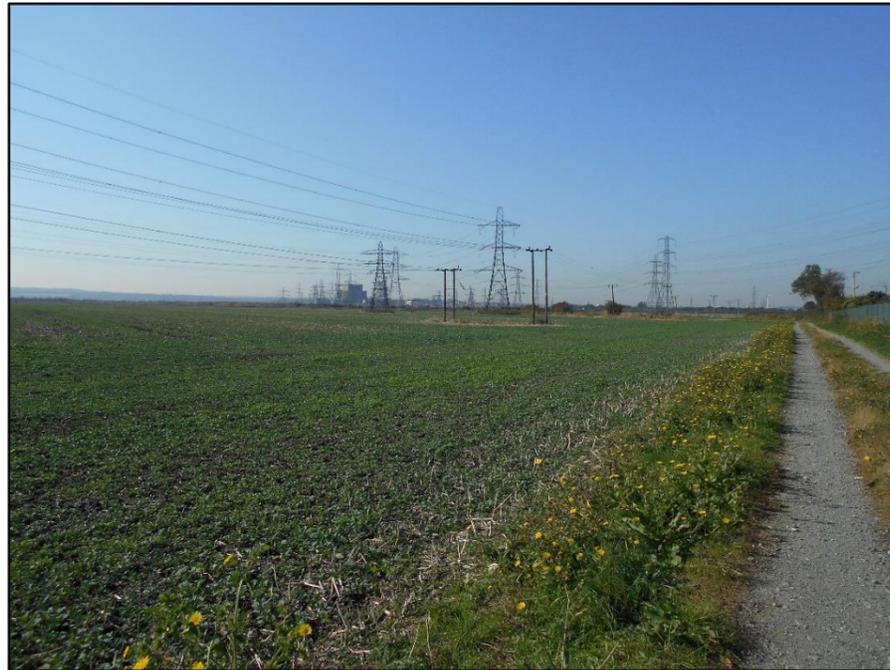
Figure 2.2: General View of Zone C.

2.1.7 Zone C comprised a corridor of land located adjacent to the south of the railway line and to the north of Zone A. The corridor comprised a gravel track in the north with a metal fence separating the site from the railway line. The gravel track was raised approximately 0.50m above the adjacent cultivated agricultural field (located in the centre to south of the zone) which formed the majority of the Zone C area. Five electricity pylons were located within Zone C. Zone C was bisected by two drainage ditches in the east and centre running north to south across the site. The drainage ditches were culverted below the track and open within the field area. The ditches were heavily vegetated with weeds and shrubs. A mound of soil and a drain/manhole cover were noted adjacent to the eastern drainage ditch. The track extended along the entire length of Zone C providing access from Station Road. Two railway crossings were also located within Zone C in the centre and west of the area. The western railway crossing was for vehicles and livestock with the central crossing for pedestrians only. A locked metal gate was located at the end of the track, at station road. A photograph of Zone C is shown in Figure 2.2.

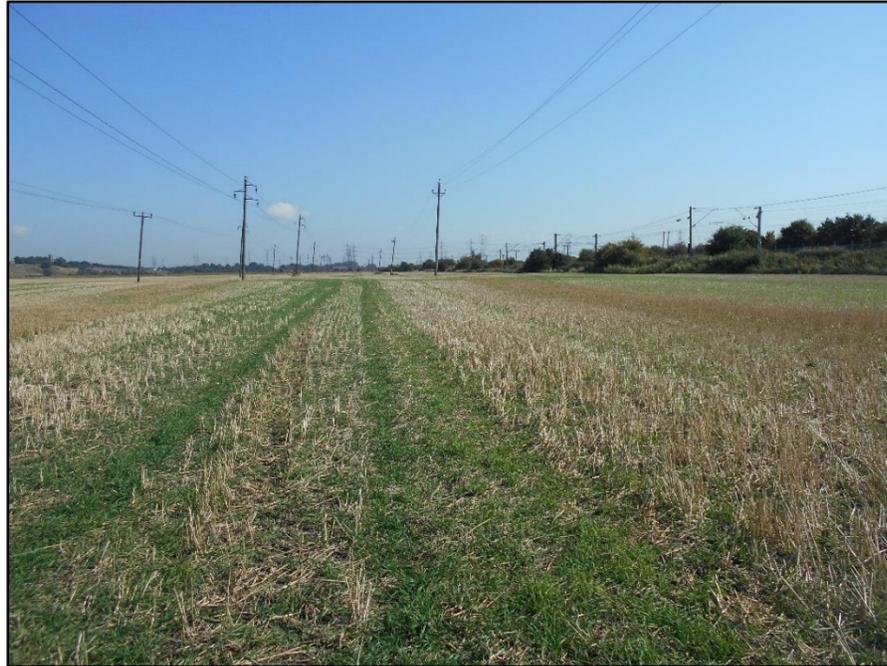
Figure 2.4: General View of Zone F1.

- 2.1.11 Zones F1 and F2 were located to the north of the railway line, extending from the edge of Grays town to the north of Zone C. Zone F1 comprised a roughly rectangular field and Zone F2 comprised part of field, both of which were located along the northern edge of the railway line. The railway line was raised approximately 0.50m above the fields. A drainage ditch was located along the western, northern and eastern edge of the field with a vegetated border comprising weeds, shrubs and reeds. The vegetated border was also raised slightly above the field level. The field comprised short grass (potentially recently cut) with a number of telegraph poles spanning its centre. A photograph of Zone F1 is shown in Figure 2.4.

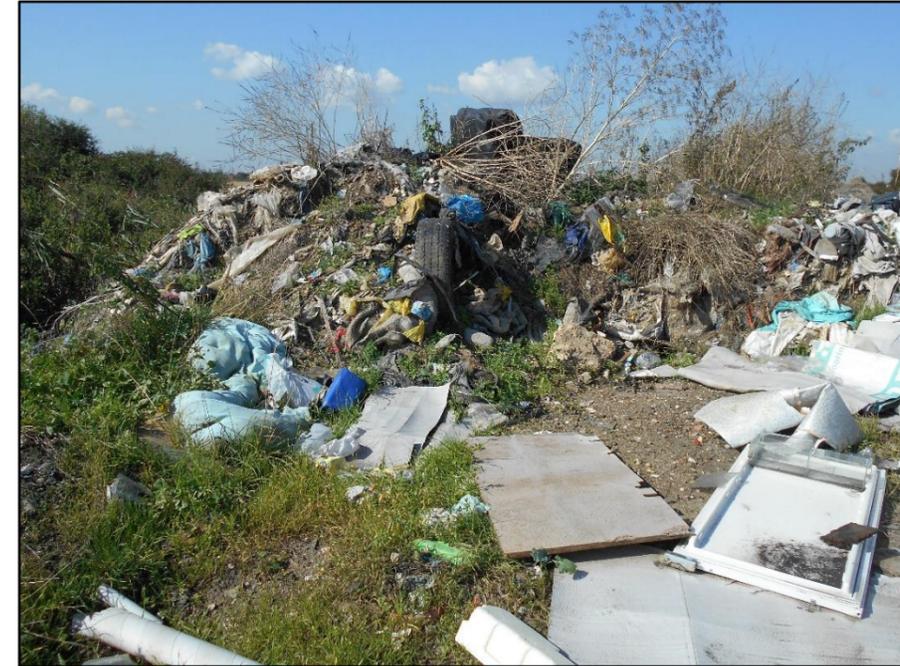
Figure 2.5: Area of Fly Tipping in Zone I.

- 2.1.13 Zone I comprised a field of long grass (approximately 0.50m tall) located to the north of the railway line, adjacent to the east of Zone F and north of Zone C. Zone I was accessed via the vehicle railway crossing from Zone C or via a track leading to the east (likely towards Station Road). One electricity pylon and a number of telegraph poles were located across Zone I. Zone I extended to the north to Cooper Shaw Road. Fly tipping was noted within Zone I adjacent to the road and included three large possible HGV tyres and rubble. Zone I was again bound by drainage ditches and dense vegetation on its eastern, northern and western sides.
- 2.1.14 A photograph showing an area of fly tipping in Zone I is shown in Figure 2.5.

3.2.6 At the time of the site walkover, a minor amount of fly tipping was observed to be present within Zone I adjacent to the road. Given its small scale and the nature of the materials, this is not considered to represent a potentially significant source of contaminants of concern. Access was not available to the HGV trailers stored in the southeast corner of Zone D.
